NM 4 THROUGH THE JEMEZ PUEBLO

ROAD SAFETY AUDIT

March 2007

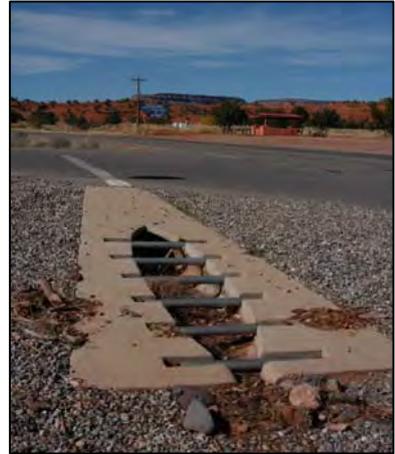
traversable drainage inlet near Walatowa Visitors Center

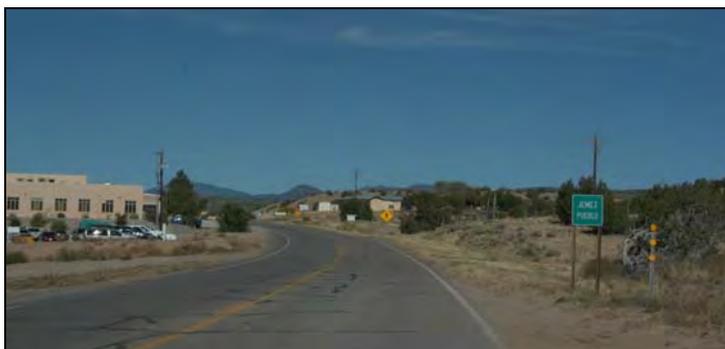
Looking north along NM4 at the entrance to the Pueblo of Jemez. NM4 is predominantly a two-lane rural road with wide shoulders, with a speed limit of 30 mph along this segment.

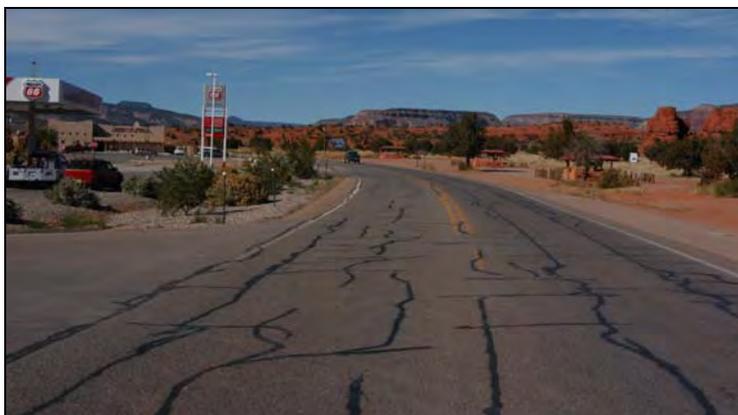
Looking north along NM4 at the Red Rocks recreational area. Roadside land uses include the commercial area (service station and Walatowa Visitors Center) visible at left, and the recreational area (where small-scale vending takes place during the summer) at right. The speed limit along this segment of the highway is 50 mph.

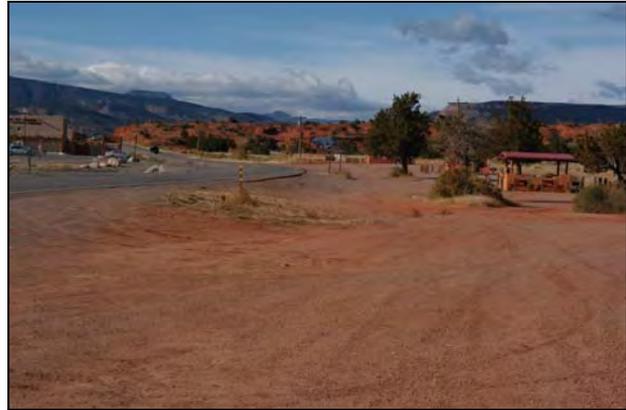
Red Rocks recreational area (above): Continuous access is provided to the large parking and vending area (at left) adjacent to a 50-mph segment of NM4. The completely unregulated access increases the risk of collisions between vehicles turning left and right into and out of this roadside area. The presence of pedestrians walking in the large open space between parked vehicles, vending stalls, and the scenic cliffs generates a risk of pedestrian collisions.

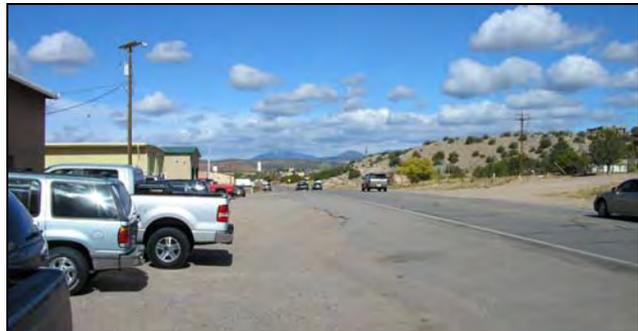
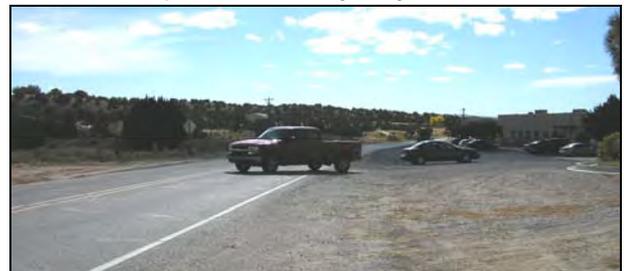
Pueblo Village area (above and below): Continuous access is provided to properties adjacent to NM4. Drivers leaving NM4 and entering the roadside area may conflict with vehicles driving in the roadside area (below), entering and leaving parking areas (above), or with pedestrians walking along the shoulder.

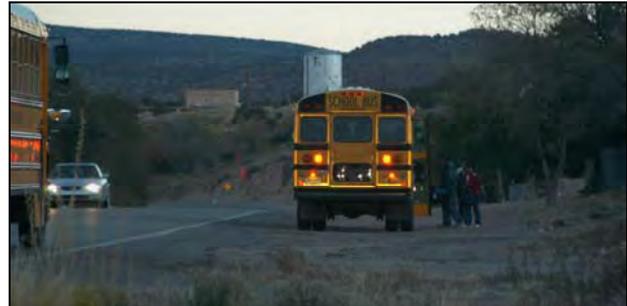
A group of students boards a schoolbus just after dawn. The students assemble at an unlighted area off the side of NM4, where they are at risk of conflict with vehicles accessing adjacent properties or vehicles dropping students off at the pick-up point.

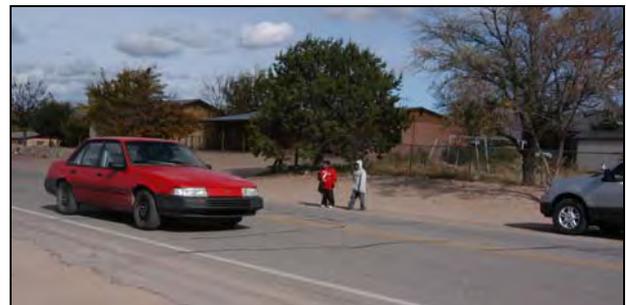
Young unaccompanied pedestrians wait to cross NM4.

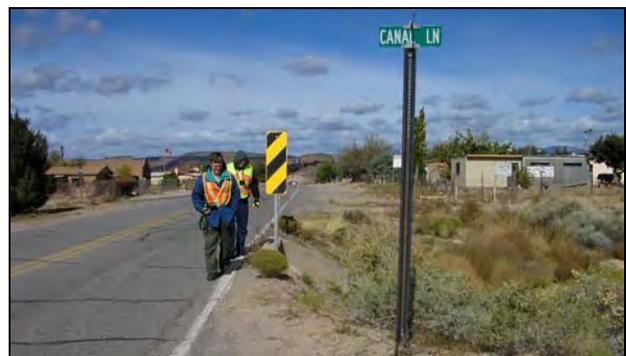
A culvert wall is located immediately adjacent to the edge of the travel lane on NM4 at Canal Lane. Pedestrians must walk in the roadway at this and similar locations.

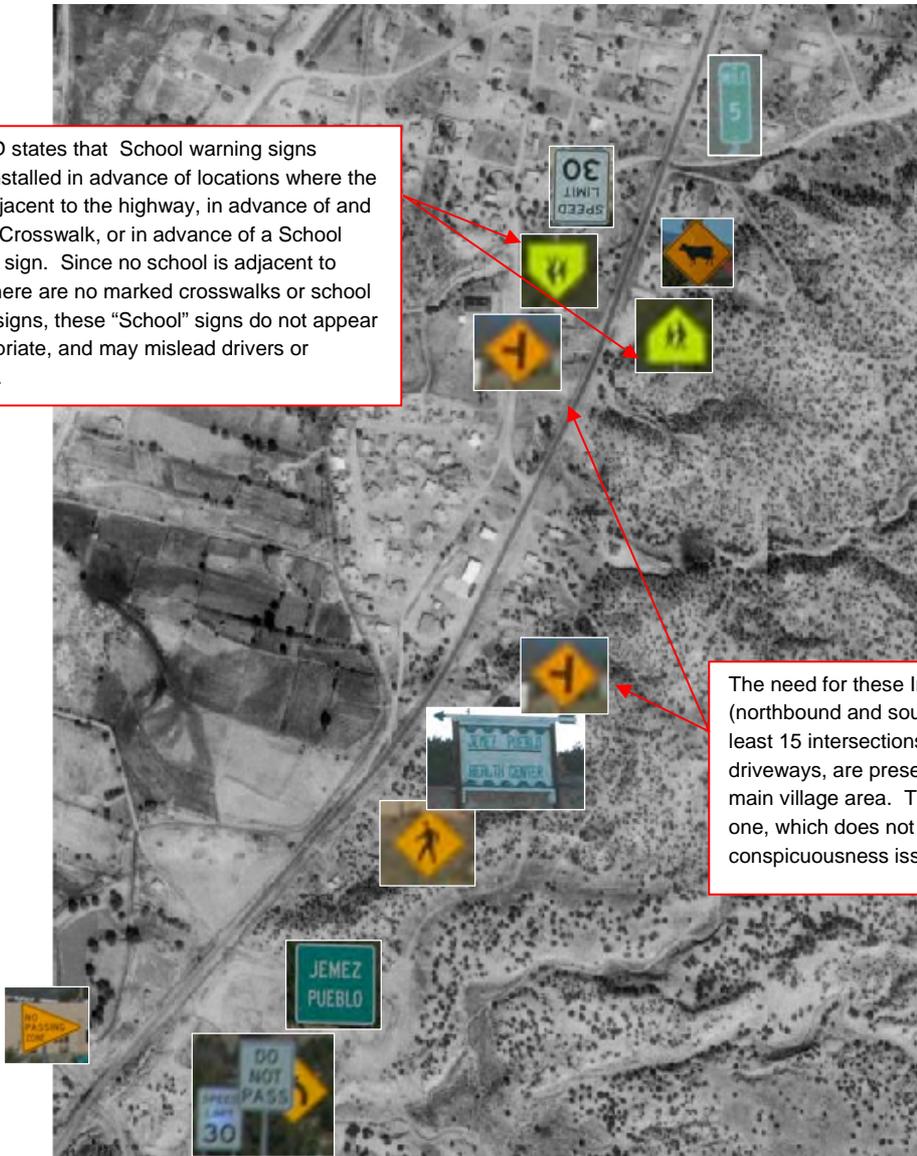
The need for these Intersection warning signs (northbound and southbound) may be reviewed. At least 15 intersections, plus numerous private driveways, are present within about 1.8 miles in the main village area. The reason for signing only this one, which does not appear to have visibility or conspicuousness issues, is not clear.

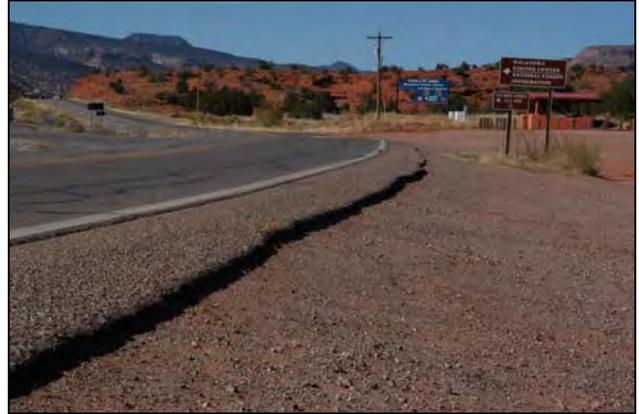
Safety Issue Description: Shoulder and pavement edge deterioration were observed during site visits (*right*). Current drainage flows appear to contribute to the deterioration by eroding and displacing supporting shoulder material, reducing the underlying support at the edge of the pavement. Pavement and shoulder deterioration caused by surface drainage flows is likely aggravated by the presence of vehicles traveling and parking on the shoulder in the residential area and Red Rocks area.

Looking north at Red Rocks recreational area: An abrupt pavement edge drop-off is visible on the east side of NM4, where the shoulder material has eroded. Drivers (especially motorcyclists) entering and exiting the shoulder, particularly at a shallow angle, may have difficulty steering if their tires catch on the pavement edge.

Stabilize shoulder. The presence of continuous accesses and parking on the shoulder (in both the main residential area and Red Rocks area) likely contributes to the deterioration of both the paved and unpaved shoulder surfaces. In the absence of access management, a program of shoulder stabilization and maintenance may be required to improve and maintain shoulder conditions. An important part of the stabilization program will be a review of surface drainage in the right of way, since drainage flows appear to be a contributing factor in the deterioration of the shoulder. Drainage improvements on NM4 through the Pueblo have been identified in the 2006 Regional Transportation Improvement Program Recommendations, and may be implemented as part of the Statewide Transportation Improvement Program (STIP).

Introduce curb and gutter. An urban cross-section would replace the shoulder with curb and gutter. This cross-section would have added benefits in terms of providing the opportunity to control access points (Issue 1 above), provide segregated pedestrian facilities (Issue 2 above), and encourage lower operating speeds (Issue 4 above).

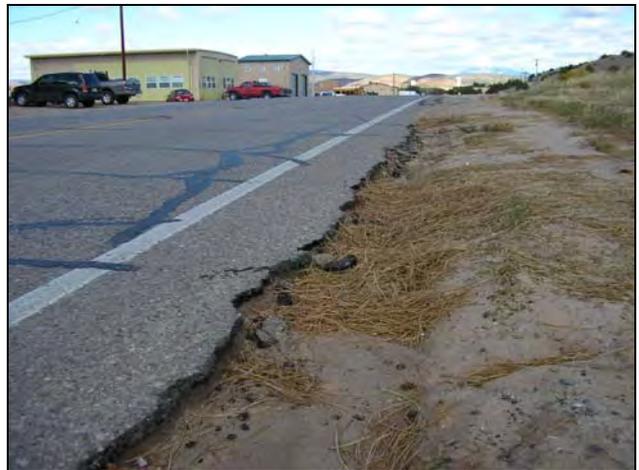
Looking north near the Pueblo government buildings: Drainage flows appear to have created channels in the exposed shoulder material, and have eroded the supporting material under the pavement, resulting in loss of the paved shoulder width and an abrupt drop-off. Drivers (especially motorcyclists) entering and exiting the shoulder, particularly at a shallow angle, may have difficulty steering if their tires catch in the channel or on the pavement edge.

- creating an uneven shoulder surface (*bottom photo on previous page*). Drivers (especially motorcyclists) may have trouble steering on the uneven and channelized surface, increasing the risk of collision with parked vehicles and pedestrians (including children at school bus stops) in the shoulder area.

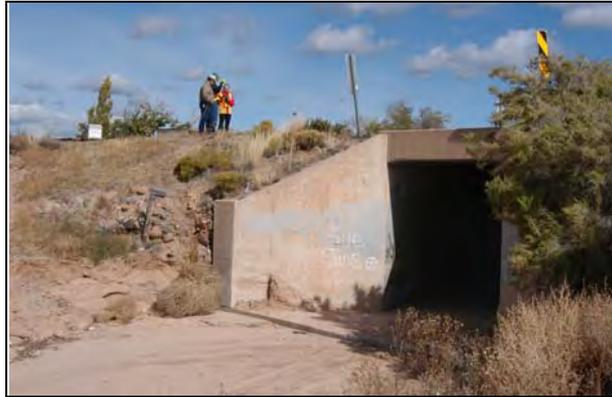
Arroyo embankment and culvert headwall adjacent to NM4 in the residential area: The RSA Team members are standing on the narrow shoulder adjacent to this embankment and headwall.

Install roadside barriers to prevent drivers from leaving travel lanes. Where hazards are present within the clear zone, roadside guardrail may be considered. Guardrails should be of an appropriate length and have adequate end treatments.

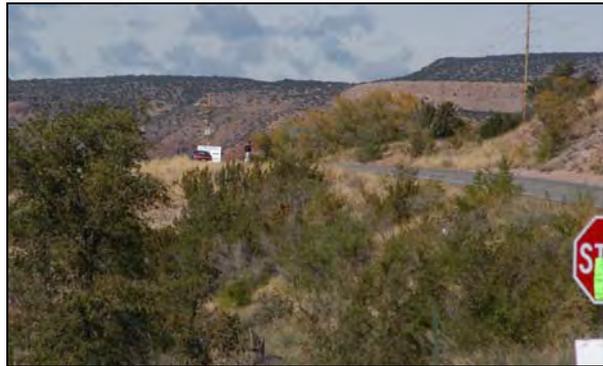
Looking north from Trading Post Road: A roadside embankment is present on the west side of NM4. Drivers leaving the roadway would be unable to recover control of their vehicle on this steep embankment.

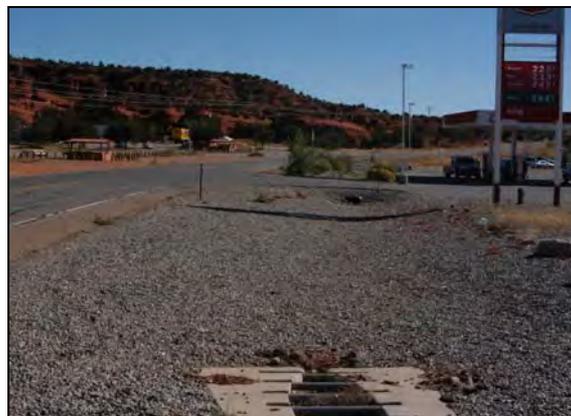
Red Rocks area: The drainage inlet the driveway beyond the gas station sign is a roadside hazard. The near inlet (visible at bottom foreground) has been designed to be crashworthy.

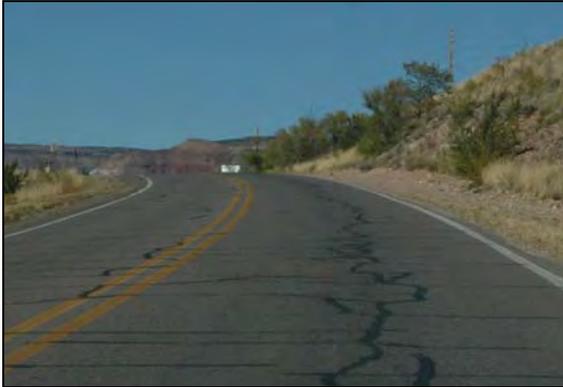
Northbound approach to Bear Canyon Road: The intersection is located over the crest, at the white sign visible toward the center of the photo. Note absence of advance intersection or pedestrian crossing signs.

On NM4 approaching Bear Canyon Road from the northbound and southbound directions (above): The unlighted intersection is located on the crest of a vertical curve. As a result, drivers' view of the intersection is limited. No "Intersection" warning signs are provided on either approach to advise drivers of the intersection, where turning and entering traffic can be expected.

- *An advance "Cross Road" (W2-1) warning sign* may be used to advise drivers on both NM4 approaches that they are approaching an intersection having limited visibility. A street name plaque ("Bear Canyon Road") may be installed above or below the Cross Road warning sign. The Cross Road sign may replace the existing Pedestrian Crossing (W11-2) sign on the southbound NM4 approach, since drivers can expect pedestrian, as well as vehicle, traffic to be crossing at the intersection.

- *Paint a “SCHOOL” pavement word marking on the approaches to the intersection. A “SCHOOL” legend may be painted on the pavement on the NM4 approaches to the intersection to advise drivers of the presence of a school adjacent to the highway. Since pavement markings will require regular maintenance, the use of durable marking material is recommended. The use of non-slip pavement markings may also be desirable to reduce the risks to motorcyclists.*

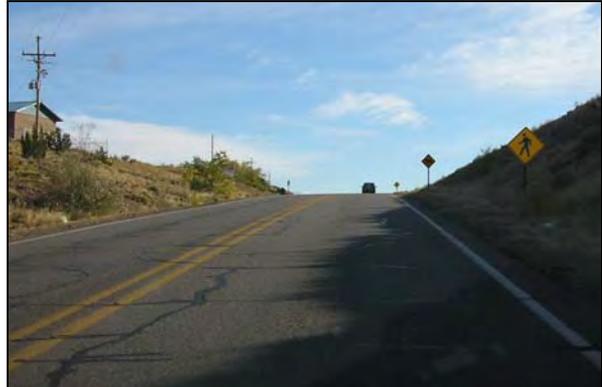
Southbound approach to Bear Canyon Road: The southbound vehicle ahead is at the intersection. The Pedestrian Crossing sign (southbound approach only) is visible in the photo.

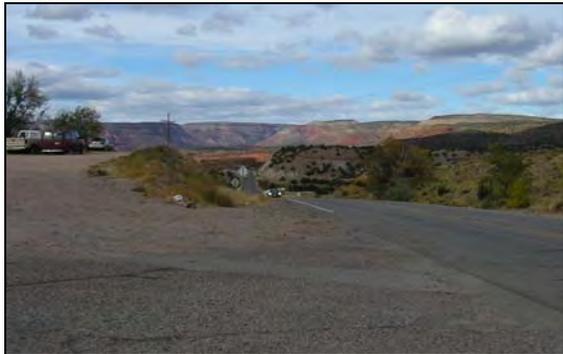
On Bear Canyon Road (west leg) looking north along NM4: A roadside embankment and vertical curve limit the view of southbound traffic approaching on NM4.

On Bear Canyon Road entering NM4 (above): The vertical curve limits the view of approaching highway traffic for drivers turning left or right out of Bear Canyon Road.

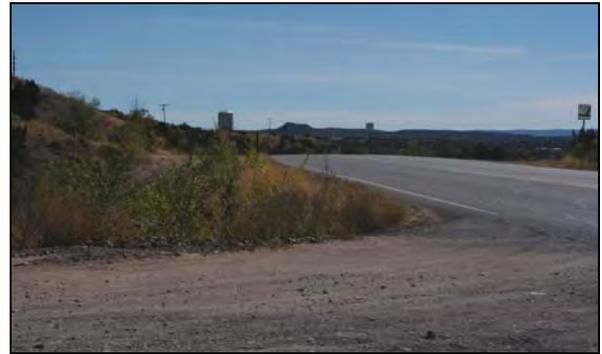
On Bear Canyon Road (east leg) looking south along NM4: The crest vertical curve limits the view of northbound traffic approaching on NM4.
