NM 4 THROUGH THE JEMEZ PUEBLO

ROAD SAFETY AUDIT

March 2007

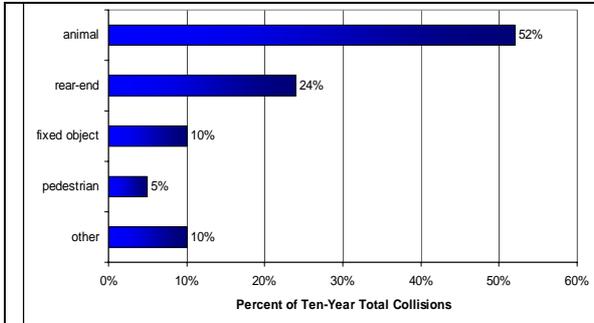
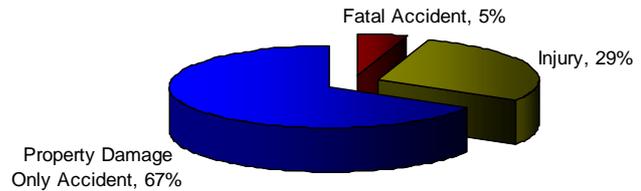
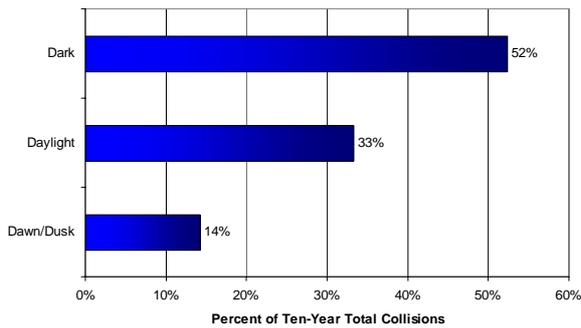
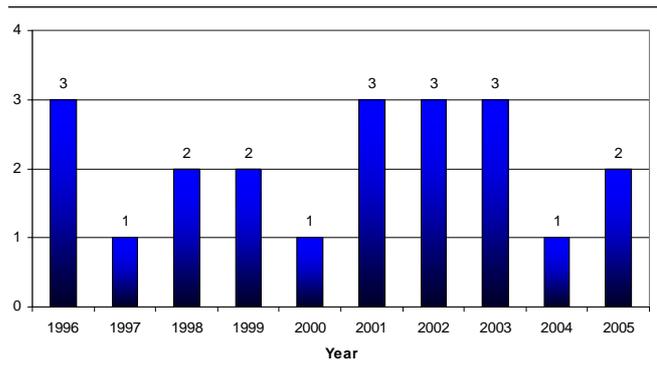
FIGURE 1.1 COLLISION DISTRIBUTIONS ALONG RESIDENTIAL SEGMENT OF NM4

Collision Types: Animal collisions predominated, accounting for over half of reported highway collisions. Rear-end crashes represented about a quarter of reported crashes. One pedestrian crash (fatal) was reported.

Crash Severity: About 1/3 of reported crashes resulted in at least one injury or fatality.

Lighting Distribution: Two-thirds of reported crashes occurred under low-light conditions (dark, dawn, or dusk).

Yearly Distribution: One, two, or three collisions occurred each year during the reporting period. No peaks were reported.

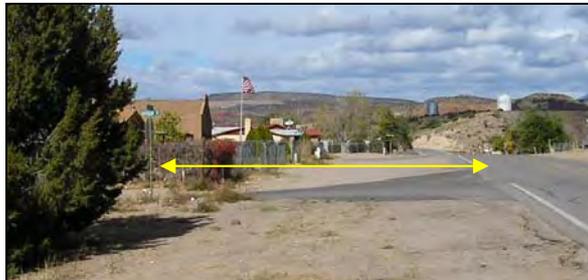
- where substantial roadside parking activity occurs (*previous page, middle right*), particularly at times of high turnover (near the Pueblo government and health center, Post Office, Civic Center, and Red Rocks recreational area);
- at night around intersections with village roads, since the intersections are unlighted, and street name signs are located at the back of the wide shoulder (*right*).

- an absence of night-time lighting that may limit the visibility of pedestrians,
- pavement edge drop-offs and uncertain shoulder conditions that may affect drivers' control of entering and exiting vehicles.

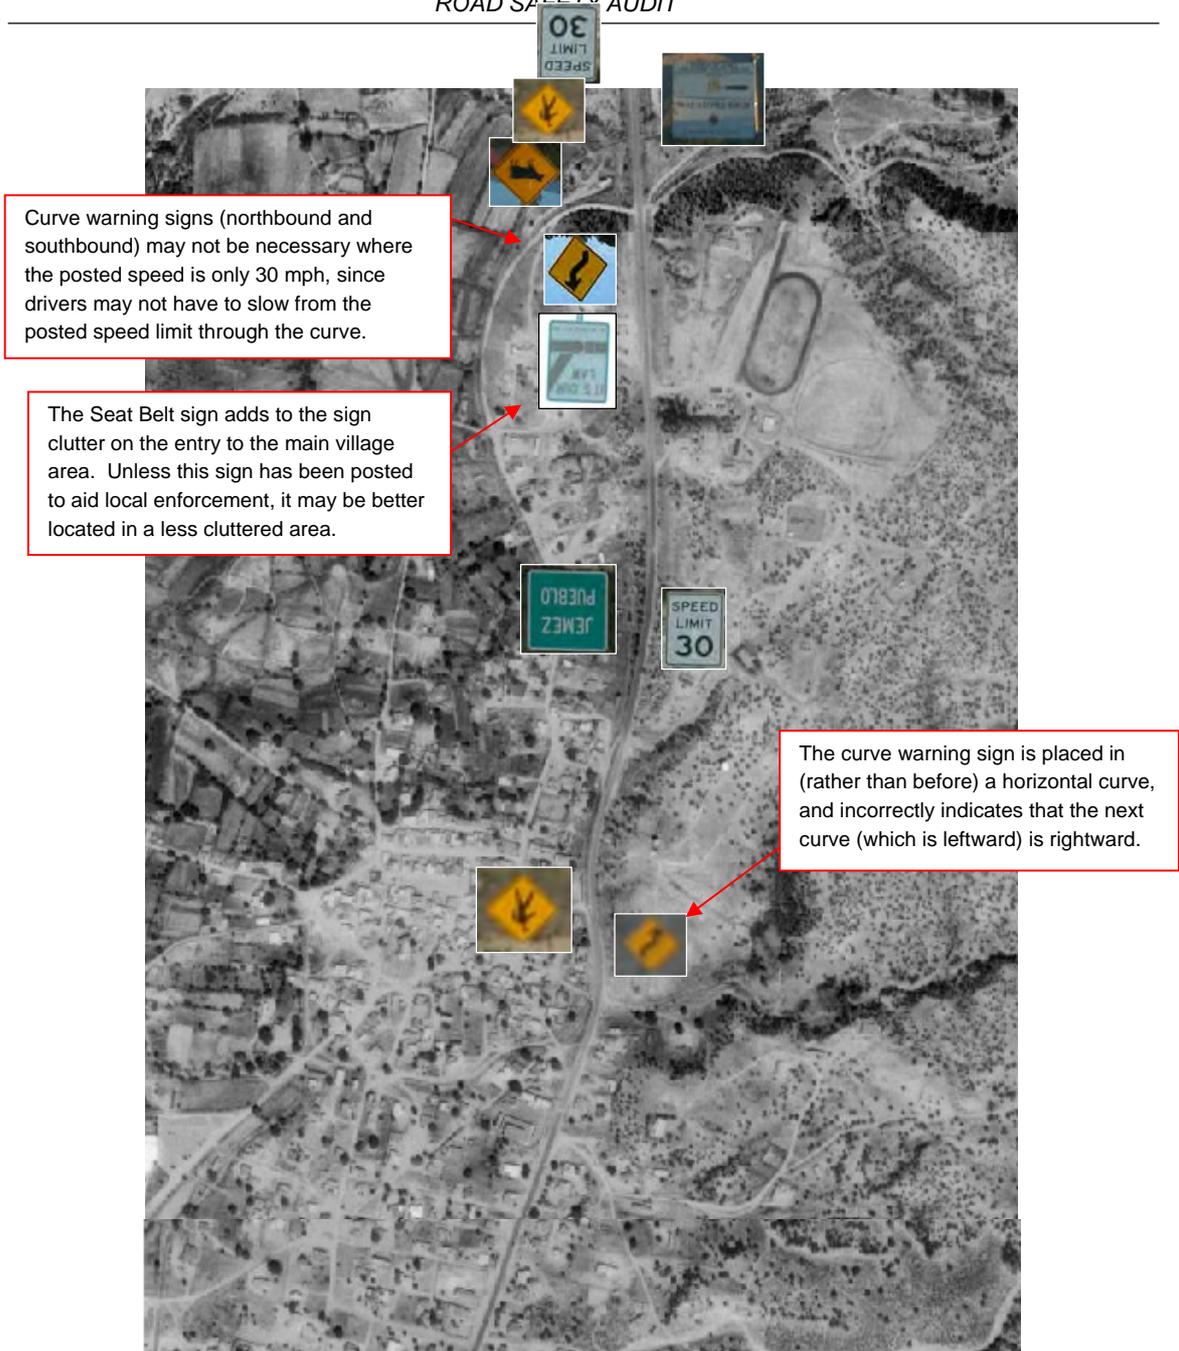
- *appropriateness:* For example, School signing, which the *Manual of Uniform Traffic Control Devices* (MUTCD) states should be installed in advance of locations where school buildings or grounds are adjacent to the highway, may not be appropriate where it is currently posted along NM4, since there is no school adjacent to the highway. The presence of unwarranted School signing may confuse drivers, and may give a false sense of security to students walking along the highway.
- *correctness:* For example, a curve warning sign posted for northbound traffic incorrectly indicates that a rightward curve where the next curve encountered by drivers is leftward.
